LAST RESORT

A creative contractor finds a way to repair a badly damaged culvert and prepare it for a permanent fix with CIPP lining

The Florida Department of Transportation's I-95/I-295 J.T. Butler Boulevard Interchange reconstruction in Jacksonville widened lanes, built bridges, and added on-off ramps with overpasses.

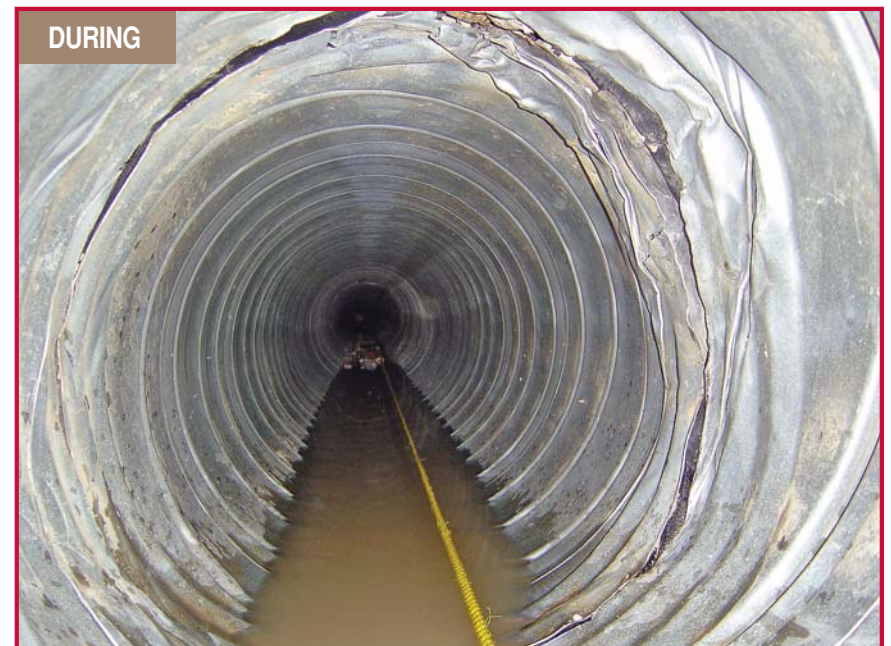
The pipe is shown after after the hydraulic cylinder pushed the corrugated metal back into place.

Lying on his back, Barton tried bending the distorted metal with a five-pound hand sledge. When it bounced off the thick pipe wall, he knew that pneumatic or hydraulic pressure would be required to reshape the metal. The team chose an Enerpac RC-Series, single-acting, 25-ton hydraulic cylinder.

“The camera monitored how far to go and when the cylinder started bogging down,” says Barton. “We also kept pressure gauges on the hydraulics to monitor the back pressure. At 25 tons of force, the cylinder bottomed out all the way.”

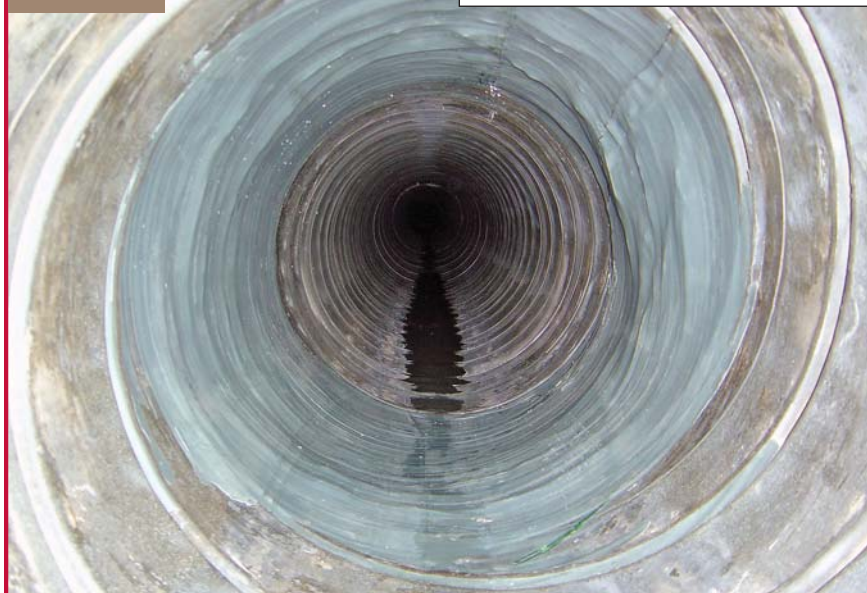
AFTER

The cured liner gives the pipe a smooth, leak-free interior.

After three-and-a-half days of jacking, the damaged metal was reflected and ready for lining. “Load bearing was a concern, so we overlapped a 3-foot, 0.20-inch thick Stephen’s Technologies New Life liner with a 4-foot one,” says Barton.

The liner, wrapped around a rubber bladder carriage, was pulled into position, inflated at 15 psi, and allowed to ambient-cure for four hours. After retracting the collapsed bladder, they video inspected the repair.
