# LAST RESORT

**A creative contractor finds a way to repair a badly damaged culvert and prepare it for a permanent fix with CIPP lining**

**Repair and line 28 inches of deflected, ruptured metal culvert without disrupting freeway traffic**

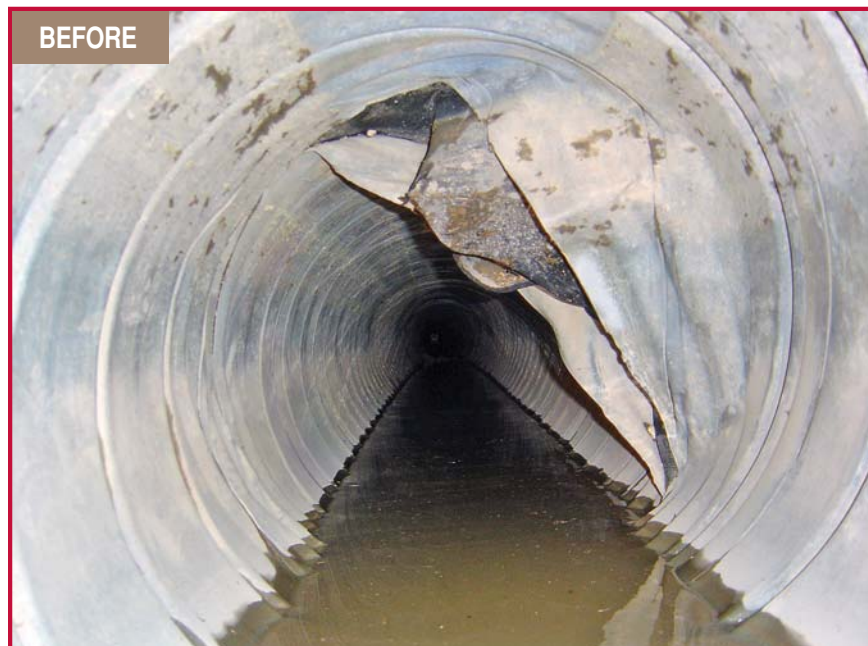
A subcontractor directional drilling to install a power conduit beneath I-95 struck a new 24-inch metal corrugated culvert running parallel under the freeway's outside southbound auxiliary lane. The impact, occurring where two butted ends of the pipe were banded together, deflected 28 inches of metal inward and downward from the 11 o'clock to 4 o'clock positions. One-third of the area's diameter was compromised.

The pipe was damaged from the 11 o'clock to 4 o'clock positions, affecting one-third of the diameter. Both pipe ends splay inward, exposing the black rubber gasket. Twelve inches of water stood in the invert.

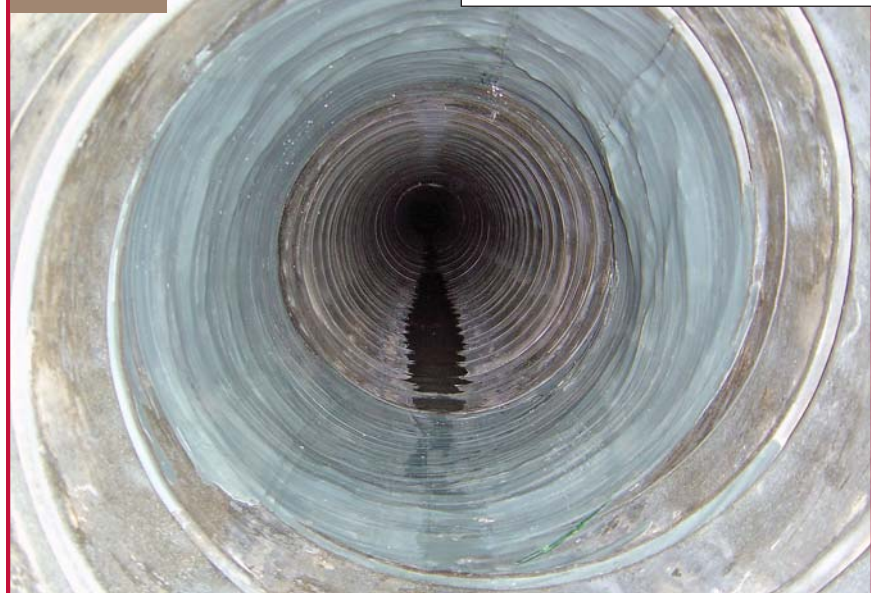
AFTER

The cured liner gives the pipe a smooth, leak-free interior.

The liner, wrapped around a rubber bladder carriage, was pulled into position, inflated at 15 psi, and allowed to ambient-cure for four hours. After retracting the collapsed bladder, they video inspected the repair.
